Manhole Inspection Summary

Manhole # S27S__005MH

Location Address: **1600 Wicomico st**

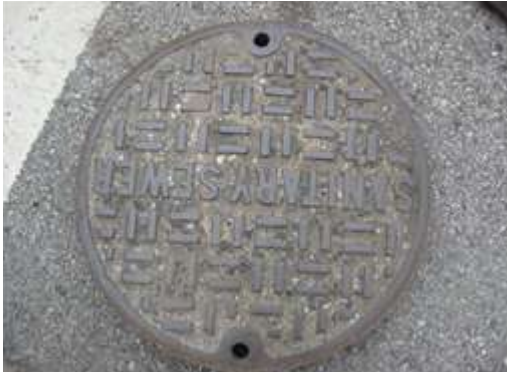
Cover View

Condition: **Sound**

Cover Material: **Cast Iron**

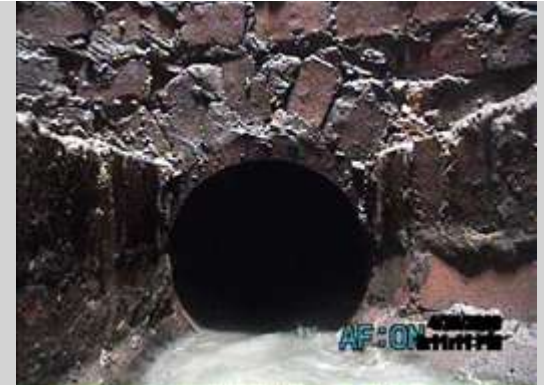
12 O'Clock Outflow

10 in. Circular Gravity Sewer
Pipe Out @ 12 O'Clock

Pipe Height: **10.8** (in.) Rod and Bar (Angled)
Pipe Material: **Clay** ☐ Pipe Lined
Invert Depth: **13.00** (ft.) Flow Characteristics: **Fast**
Deposits: ☒ None ☐ Mud ☐ Sludge ☐ Debris ☐ Grease
Silt Depth: **0** (in.) Deposits Extent:
Infiltration: **None** Pipe Seal Cond: **Sound**
